26 August 2020

**Subject: Gas Monitoring and Control System Restoration Completion Letter –
Response to Additional Comments from DTSC
Genentech Building 48
645 East Grand Avenue
South San Francisco, California 94080
Langan Project No. 731677307**

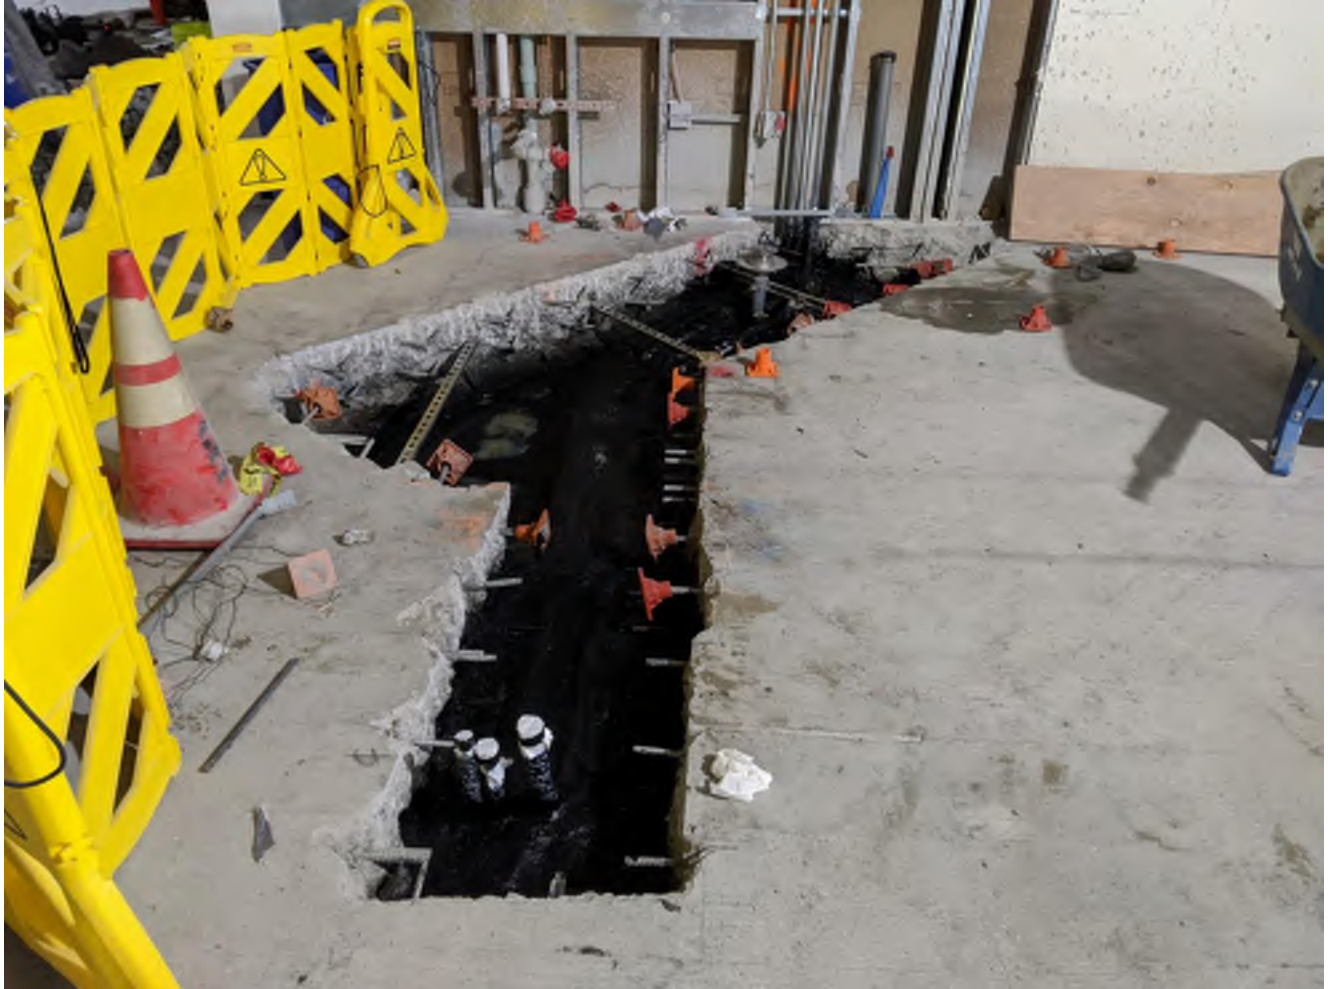
Photo 1: Post vapor barrier application to north western most repair section (facing west).

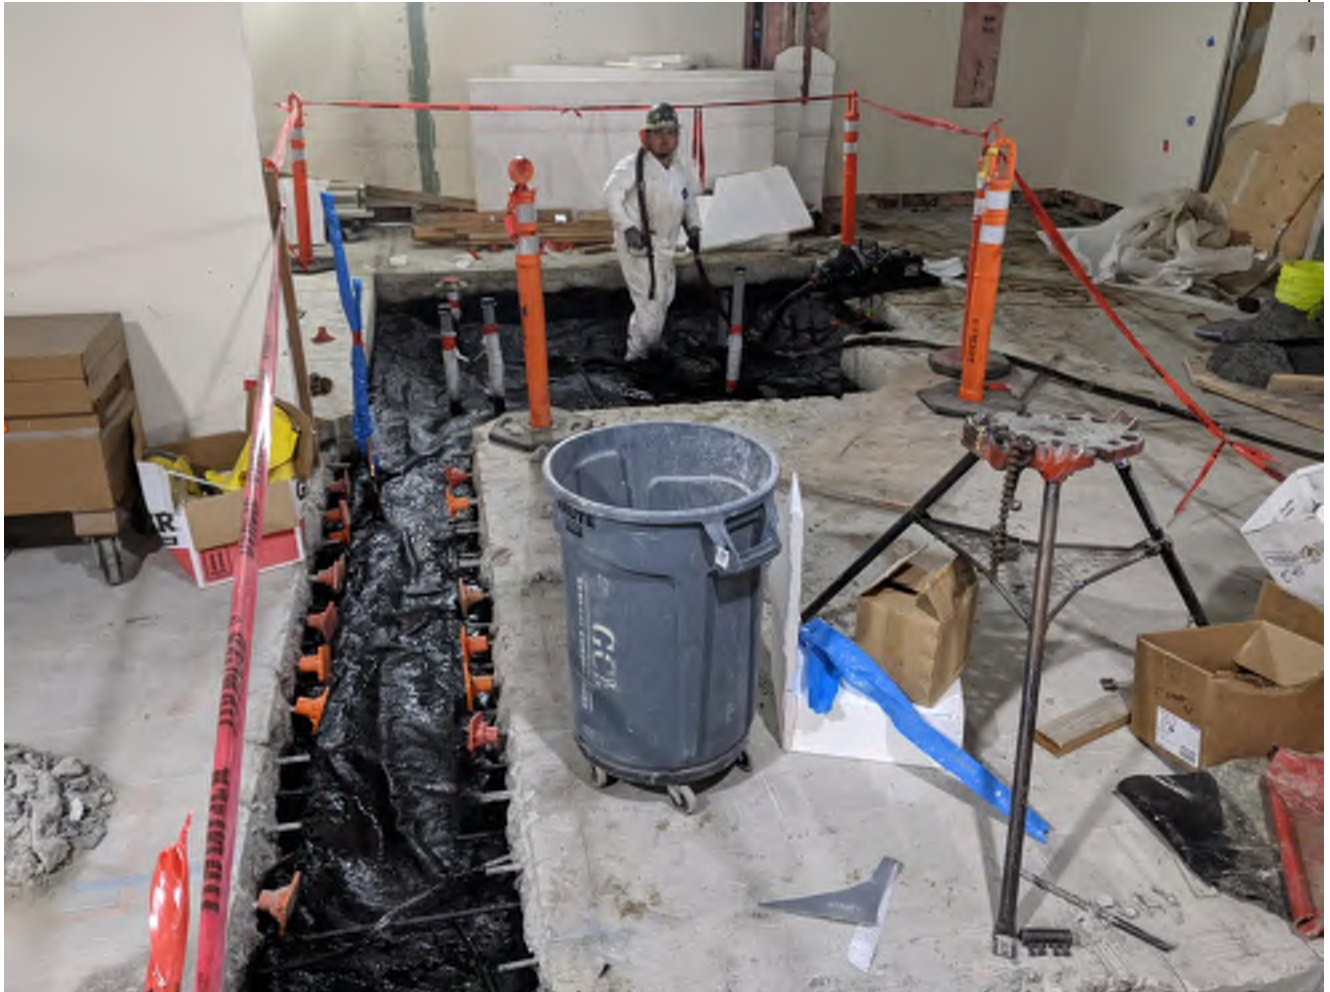
Photo 2: EPRO applied to eastern-most section of GMCS repair (facing east).

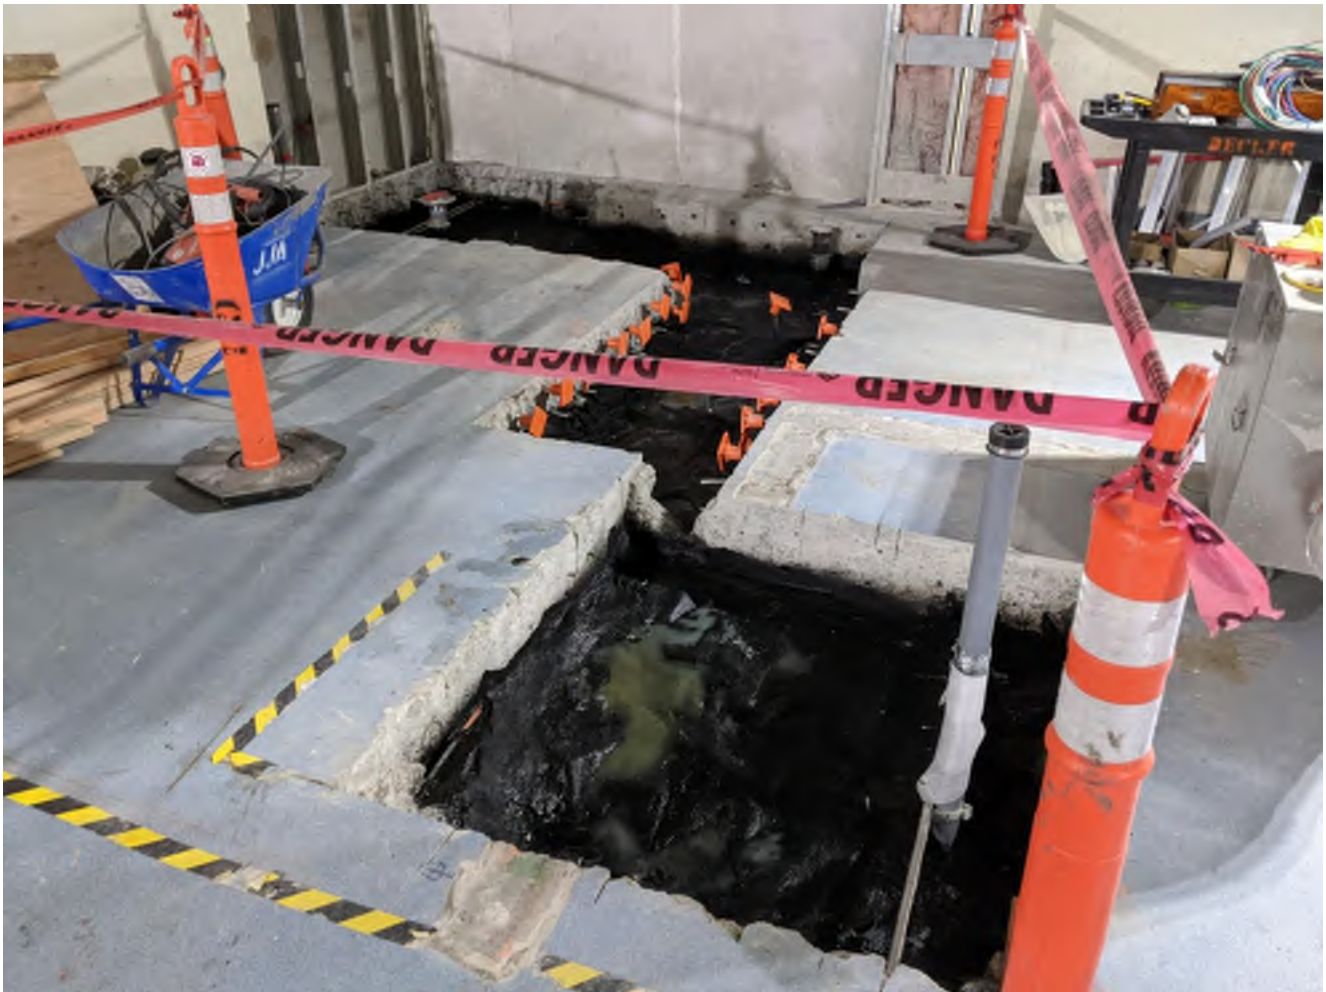
Photo 3: EPRO applied to center-most section of GMCS repair area (facing south).

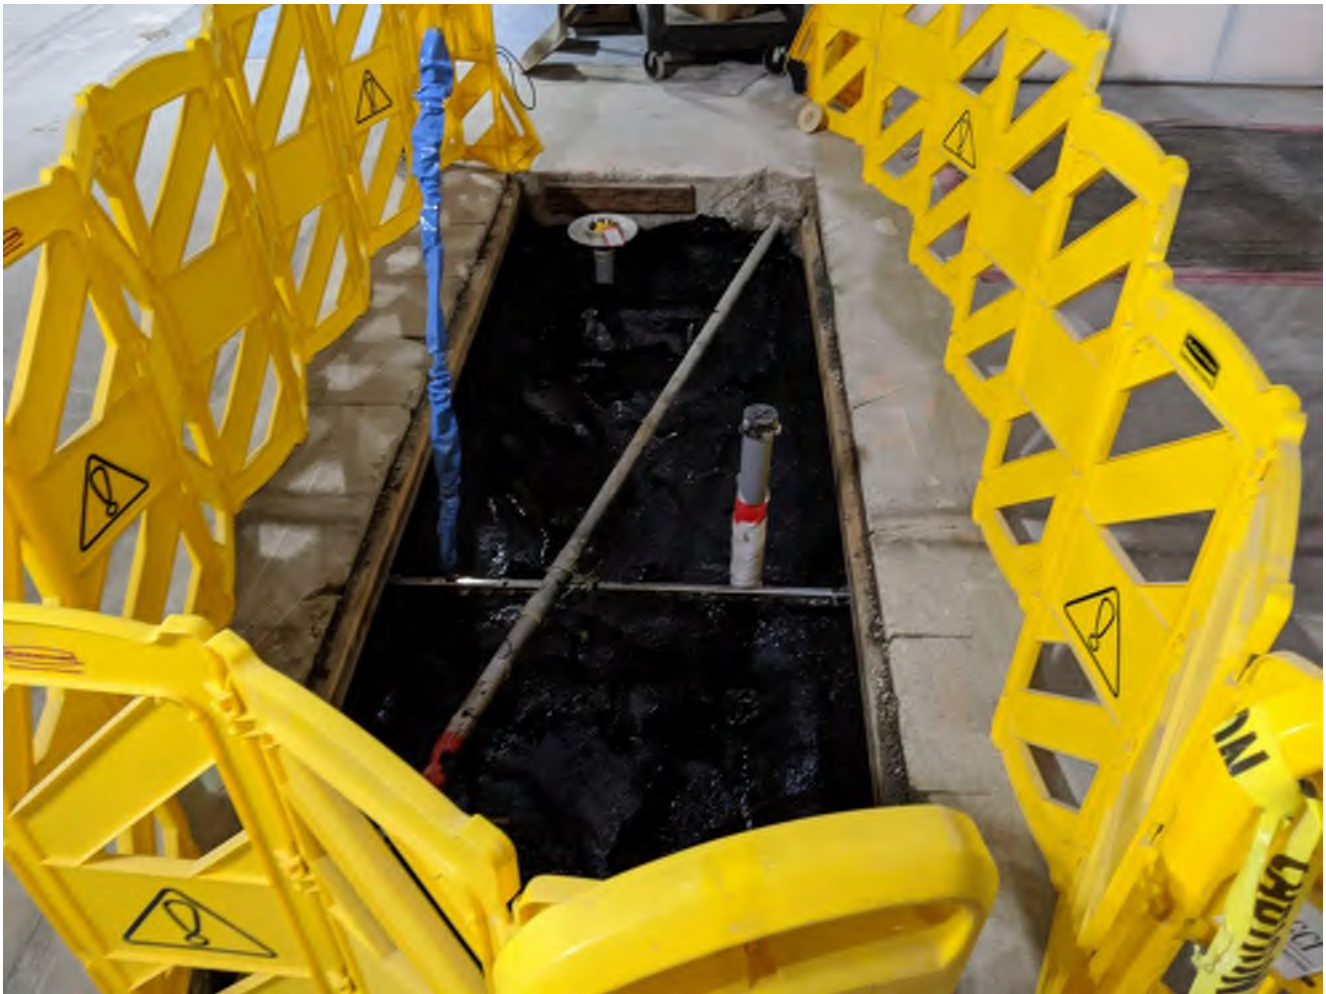
Photo 4: EPRO applied to GMCS repair where ½" gas monitoring pipe was replaced (facing west).

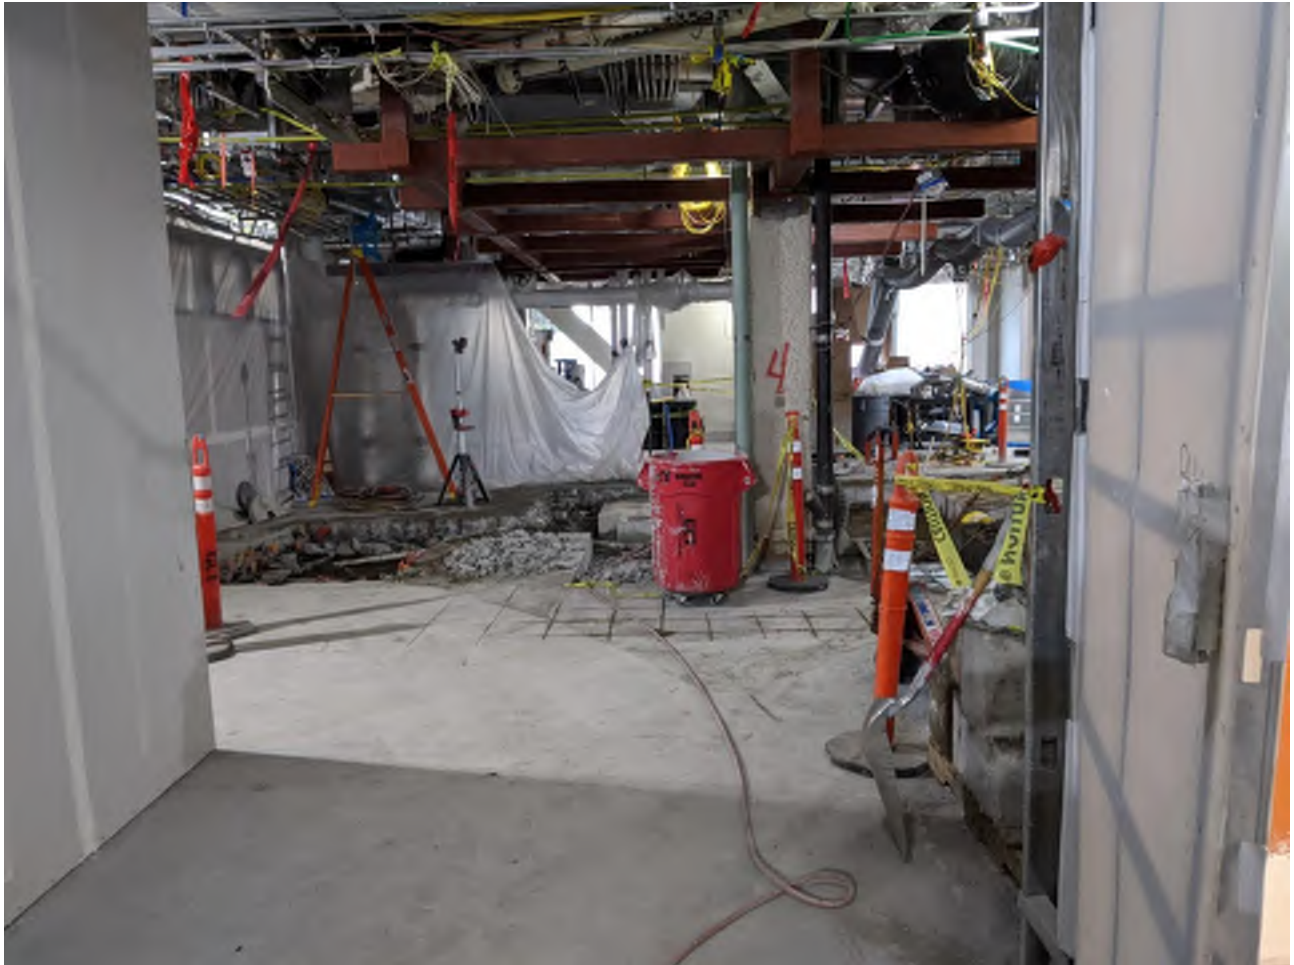
Photo 1: Wide view of Saw Cutting Phase 2 area from the loading dock entrance (facing north).

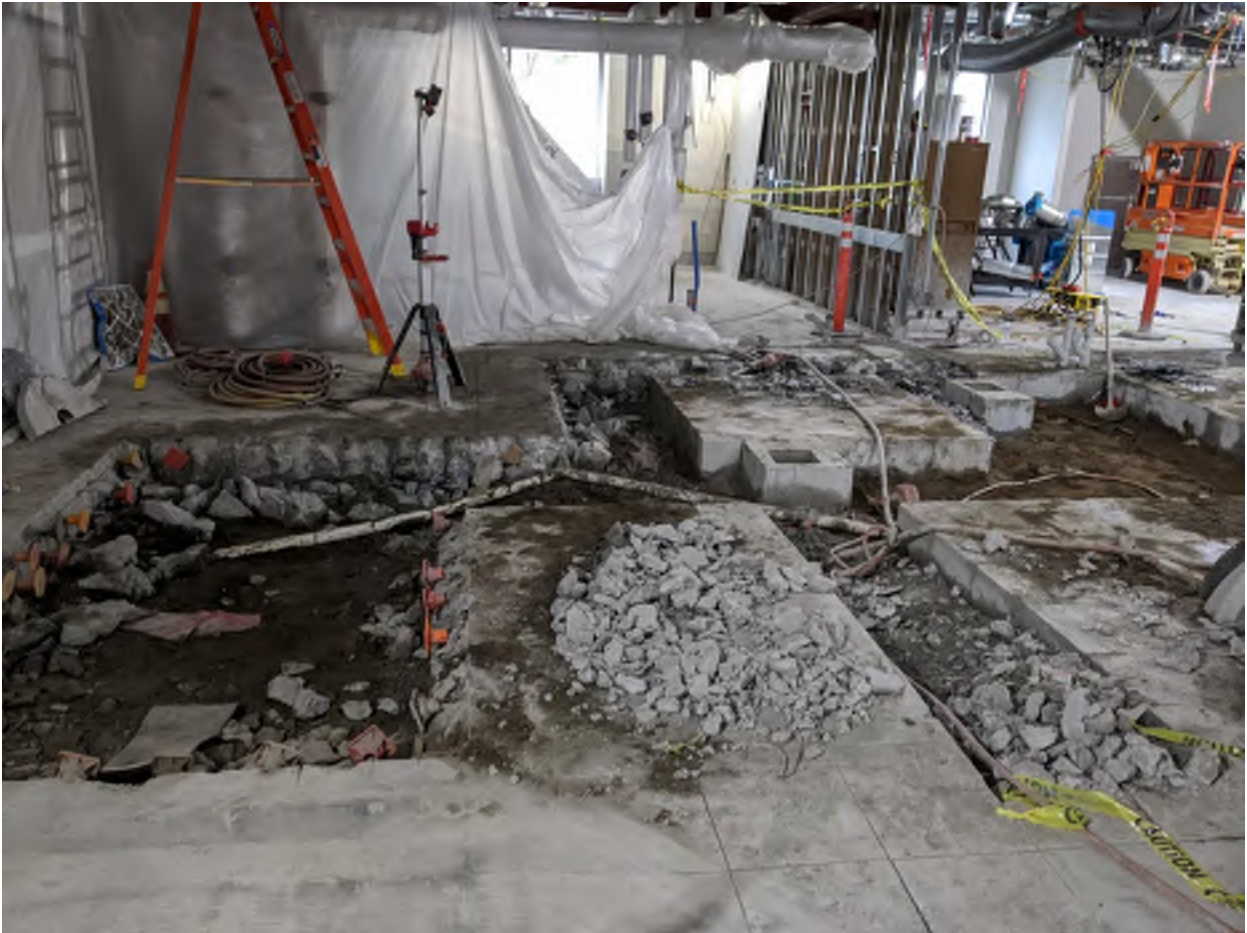
Photo 2: View of Saw Cutting Phase 2 and cut 2" PVC gas extraction pipe (facing north).

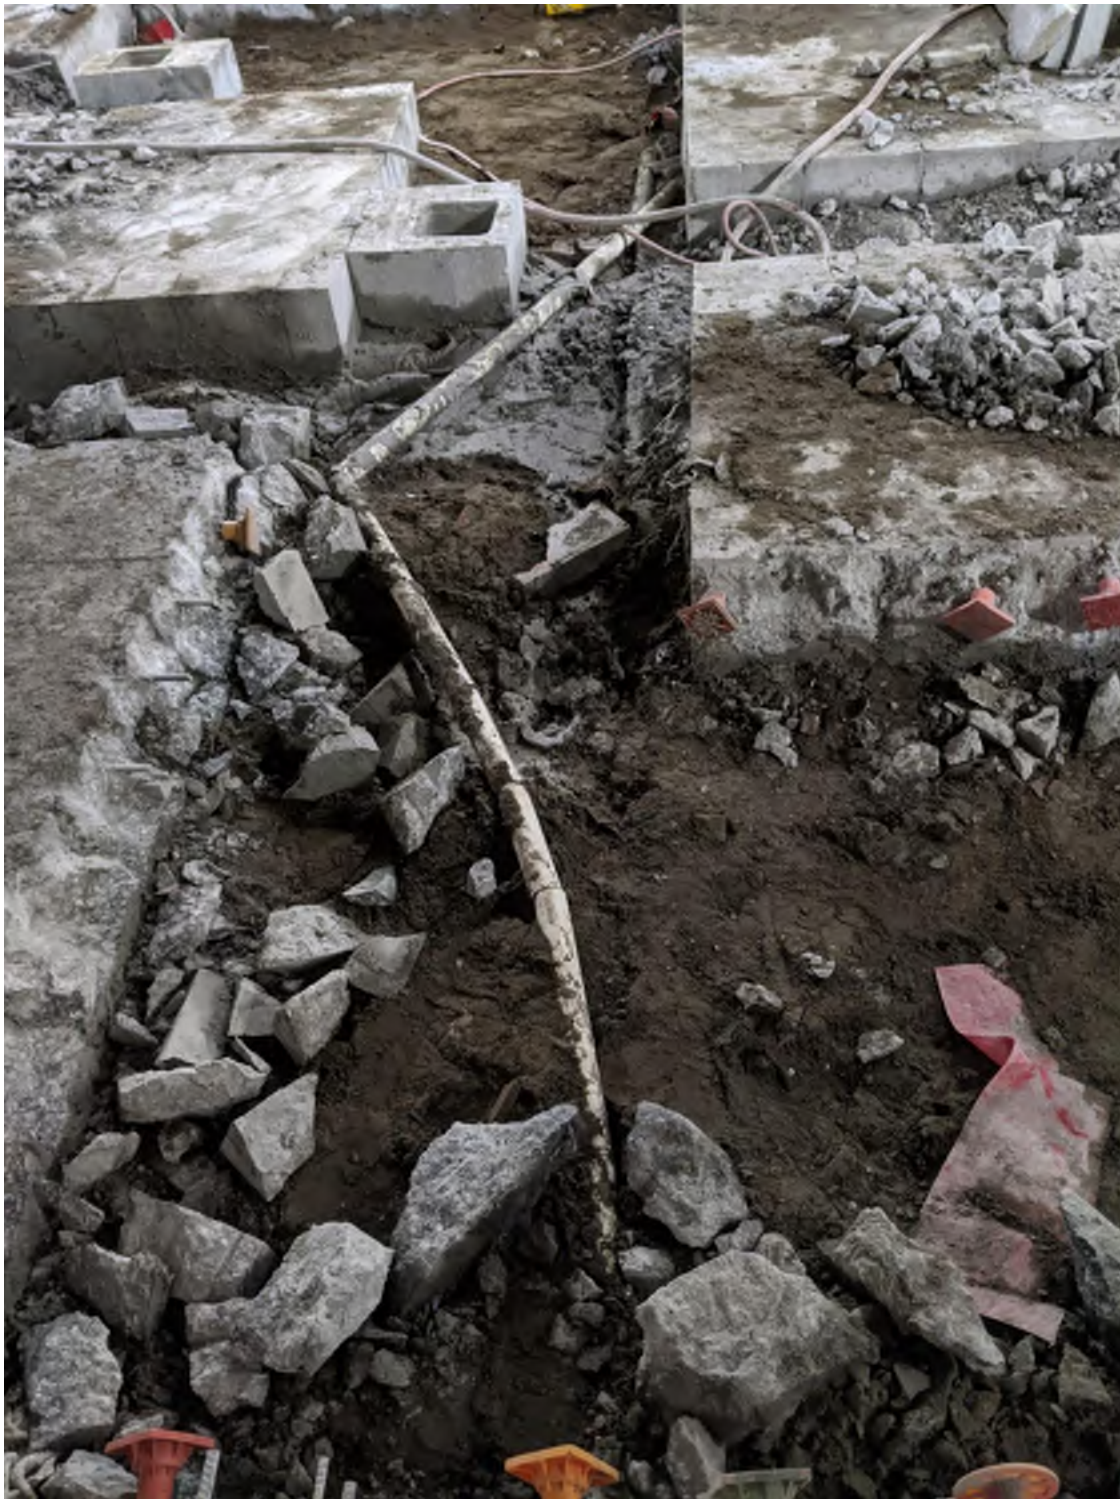
Photo 3: View of 2" PVC gas extraction pipe cut during Phase 2 Saw Cutting (facing west).

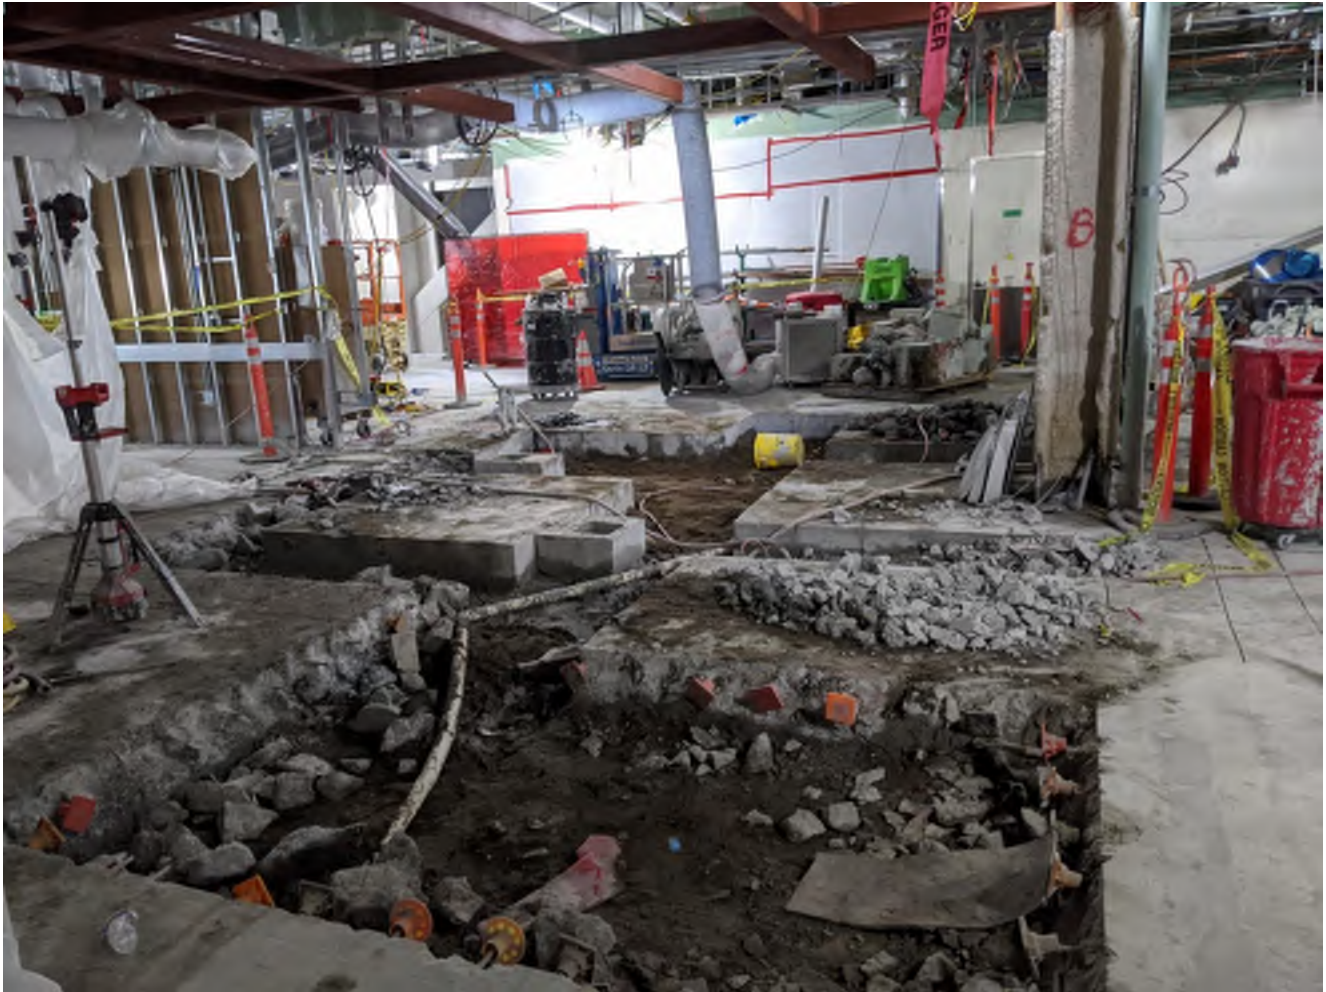
Photo 4: View of Phase 2 Saw Cutting area and cut 2" PVC gas extraction pipe (facing west).

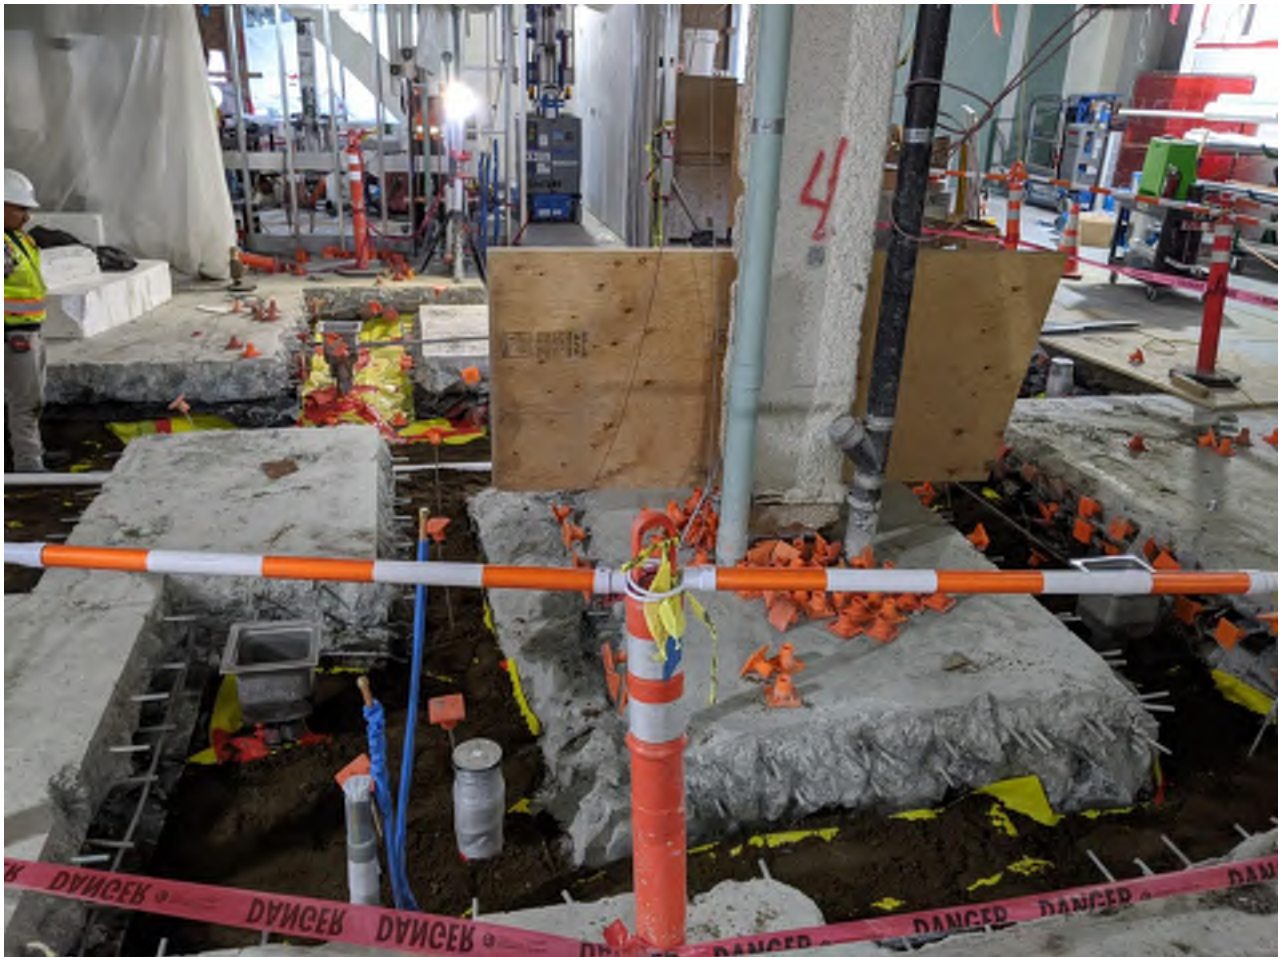
Photo 1: Phase 2 excavation area within B48 (facing north).

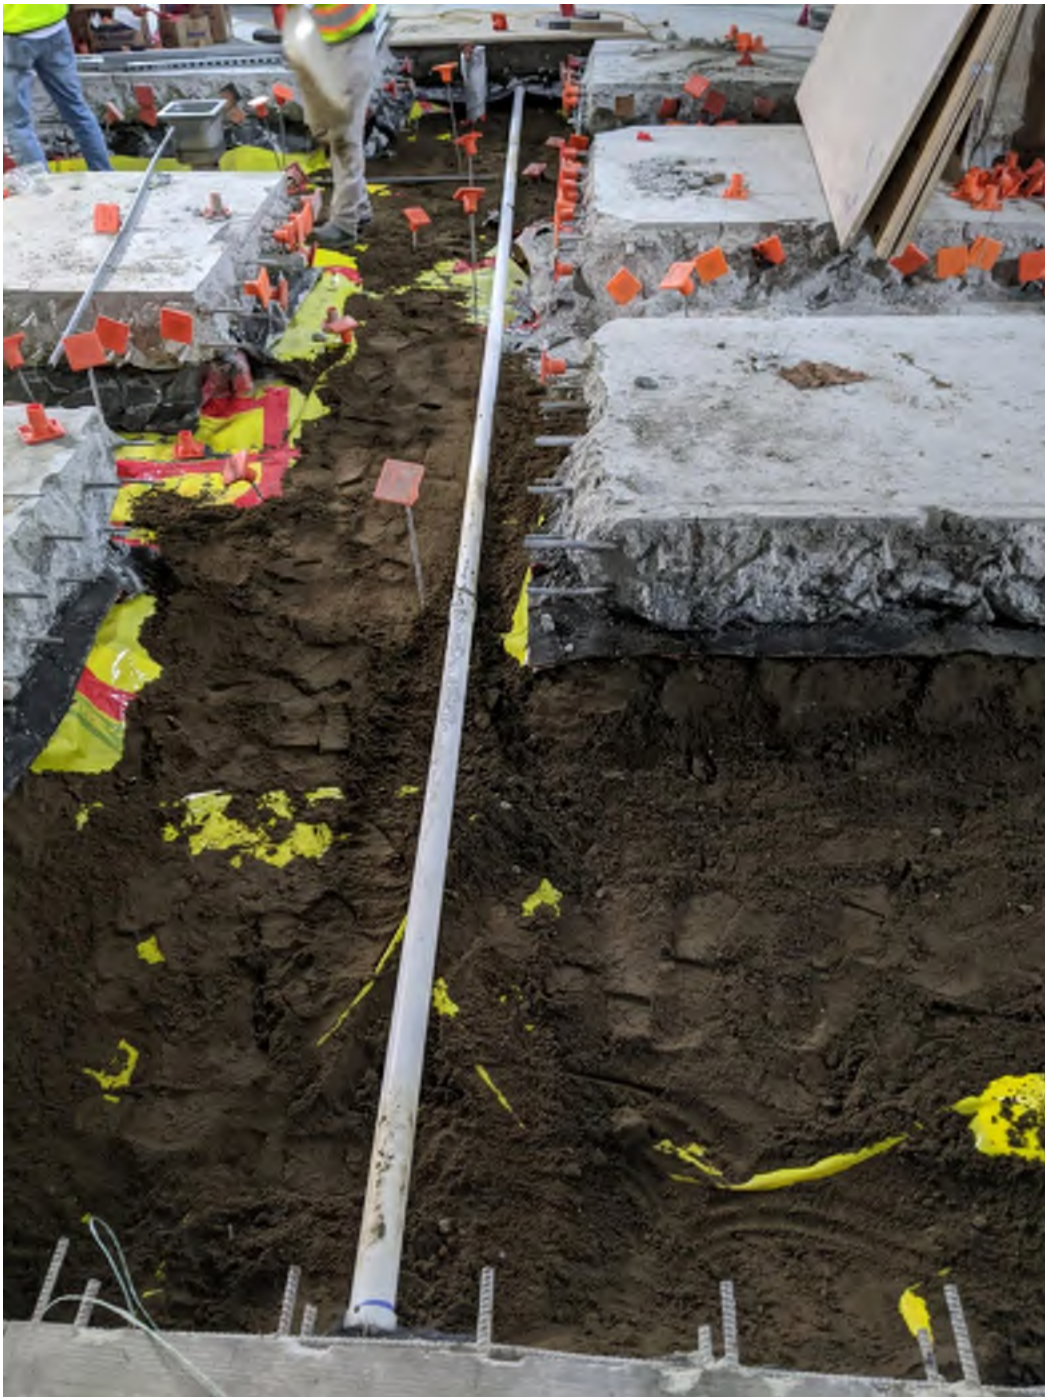
Photo 2: Fully repaired 2" PVC gas extraction pipe (facing east).

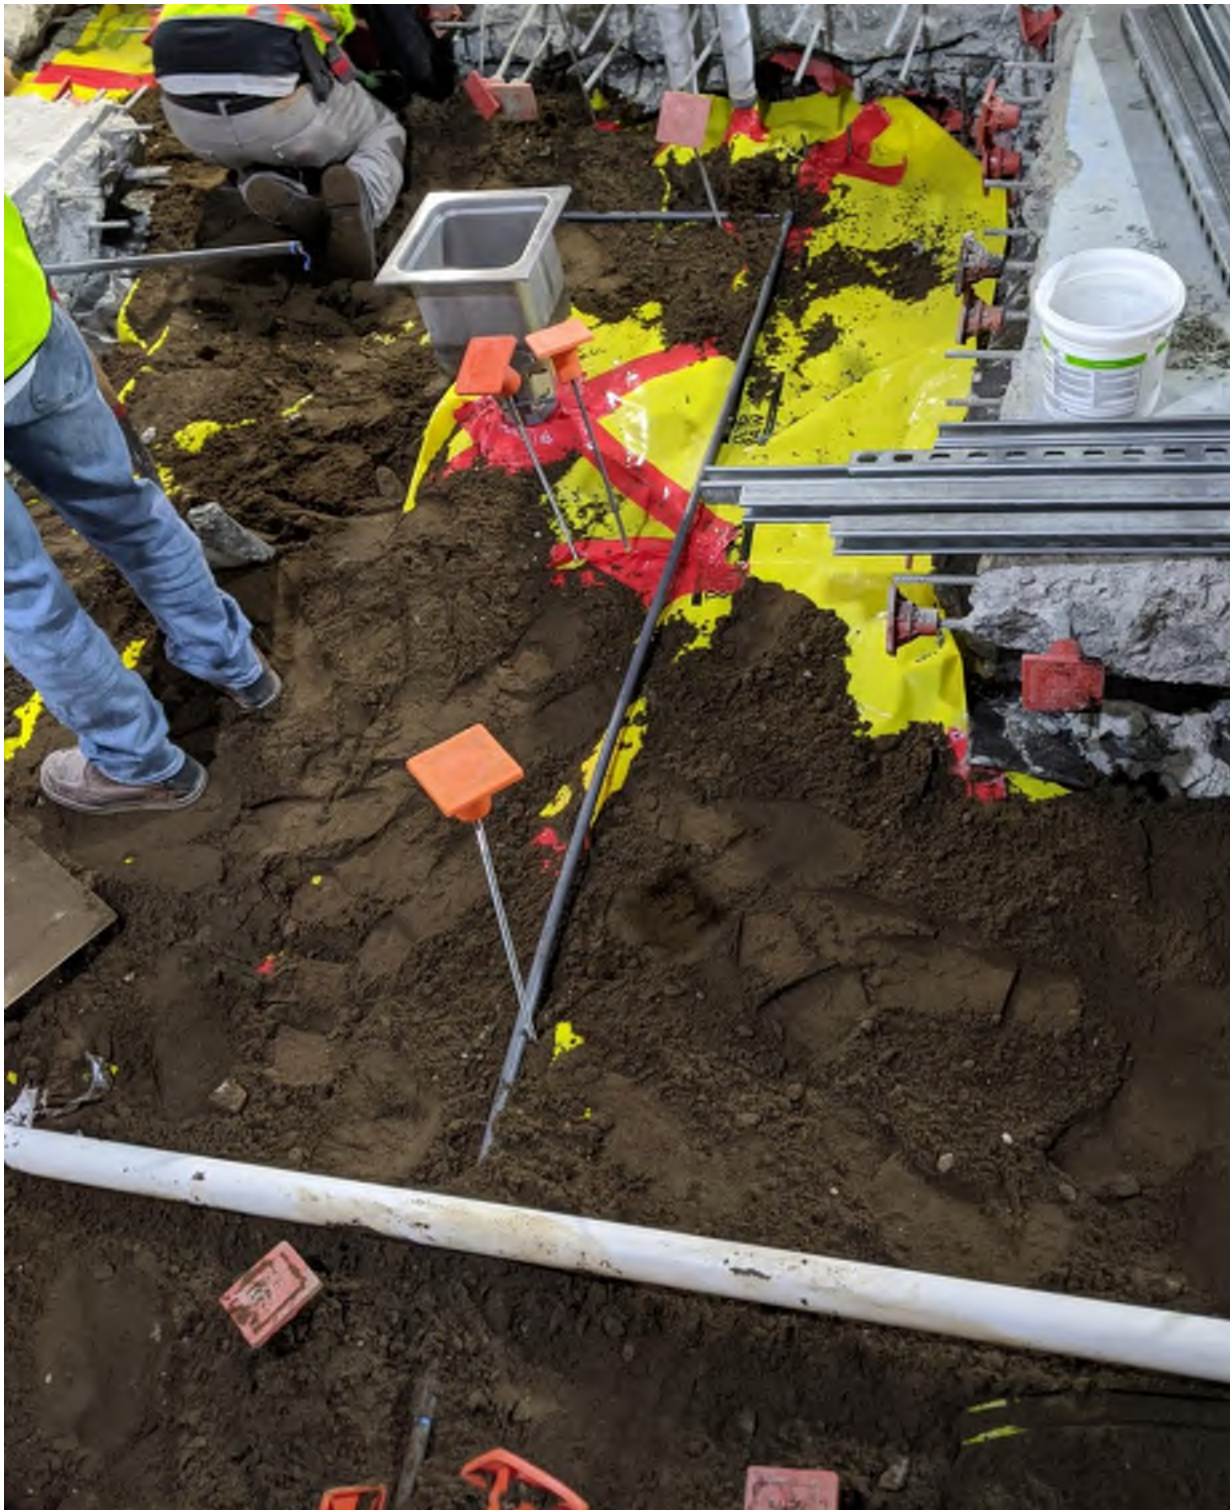
Photo 3: Fully repaired 1/2" solid gas monitoring pipe (facing north).

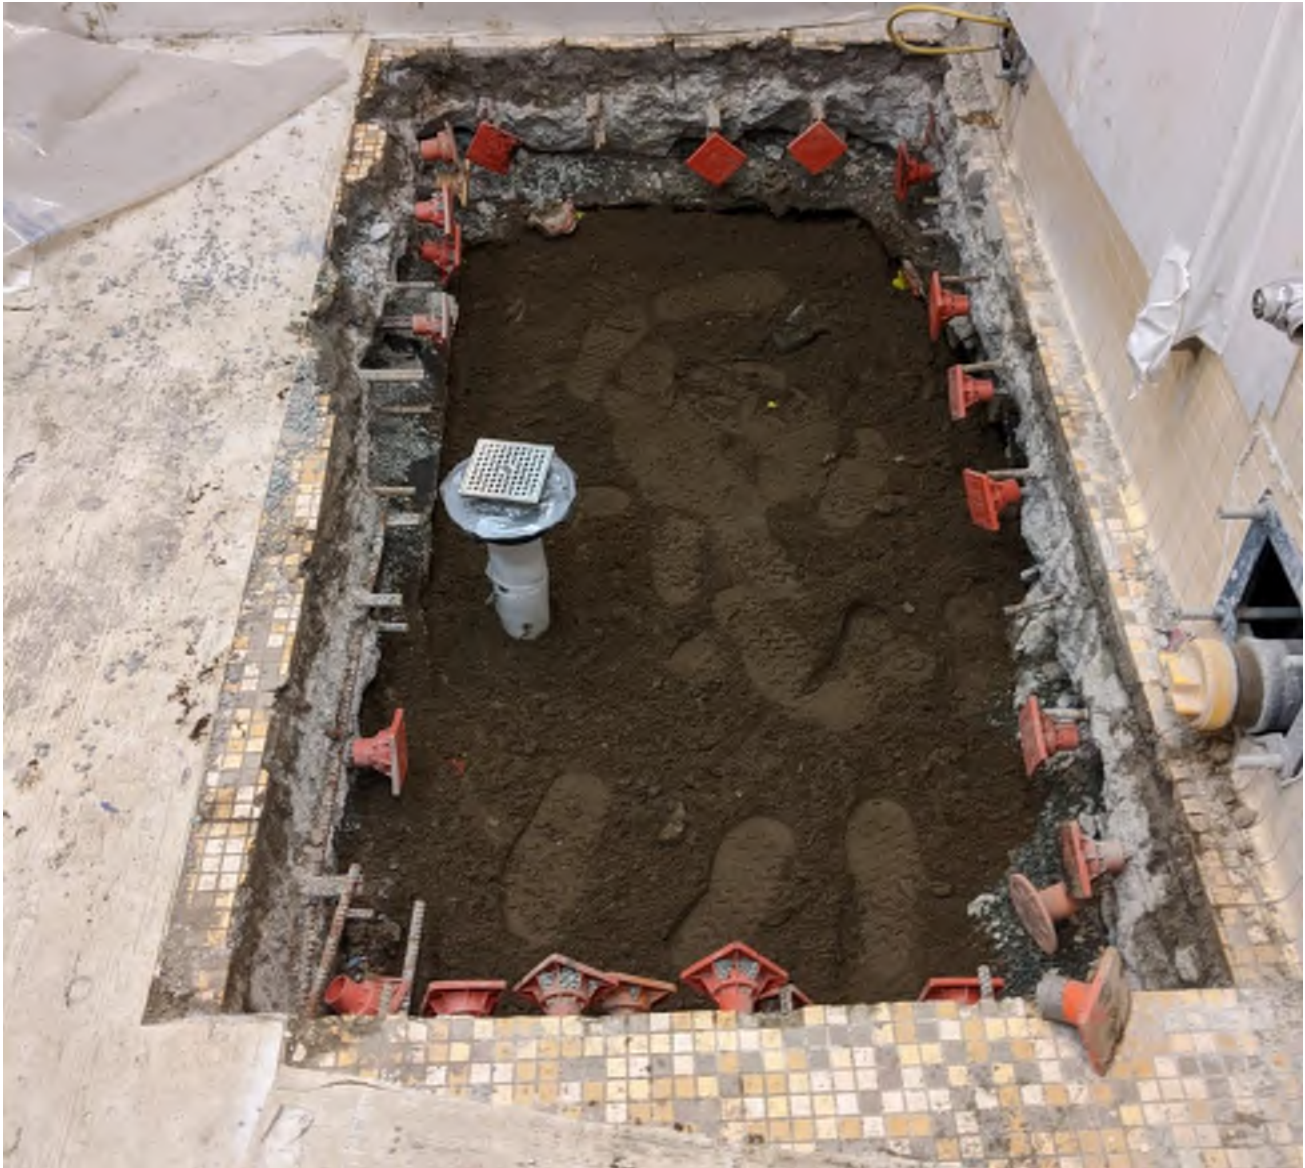
Photo 4: View of small excavation area within men's bathroom (facing west).

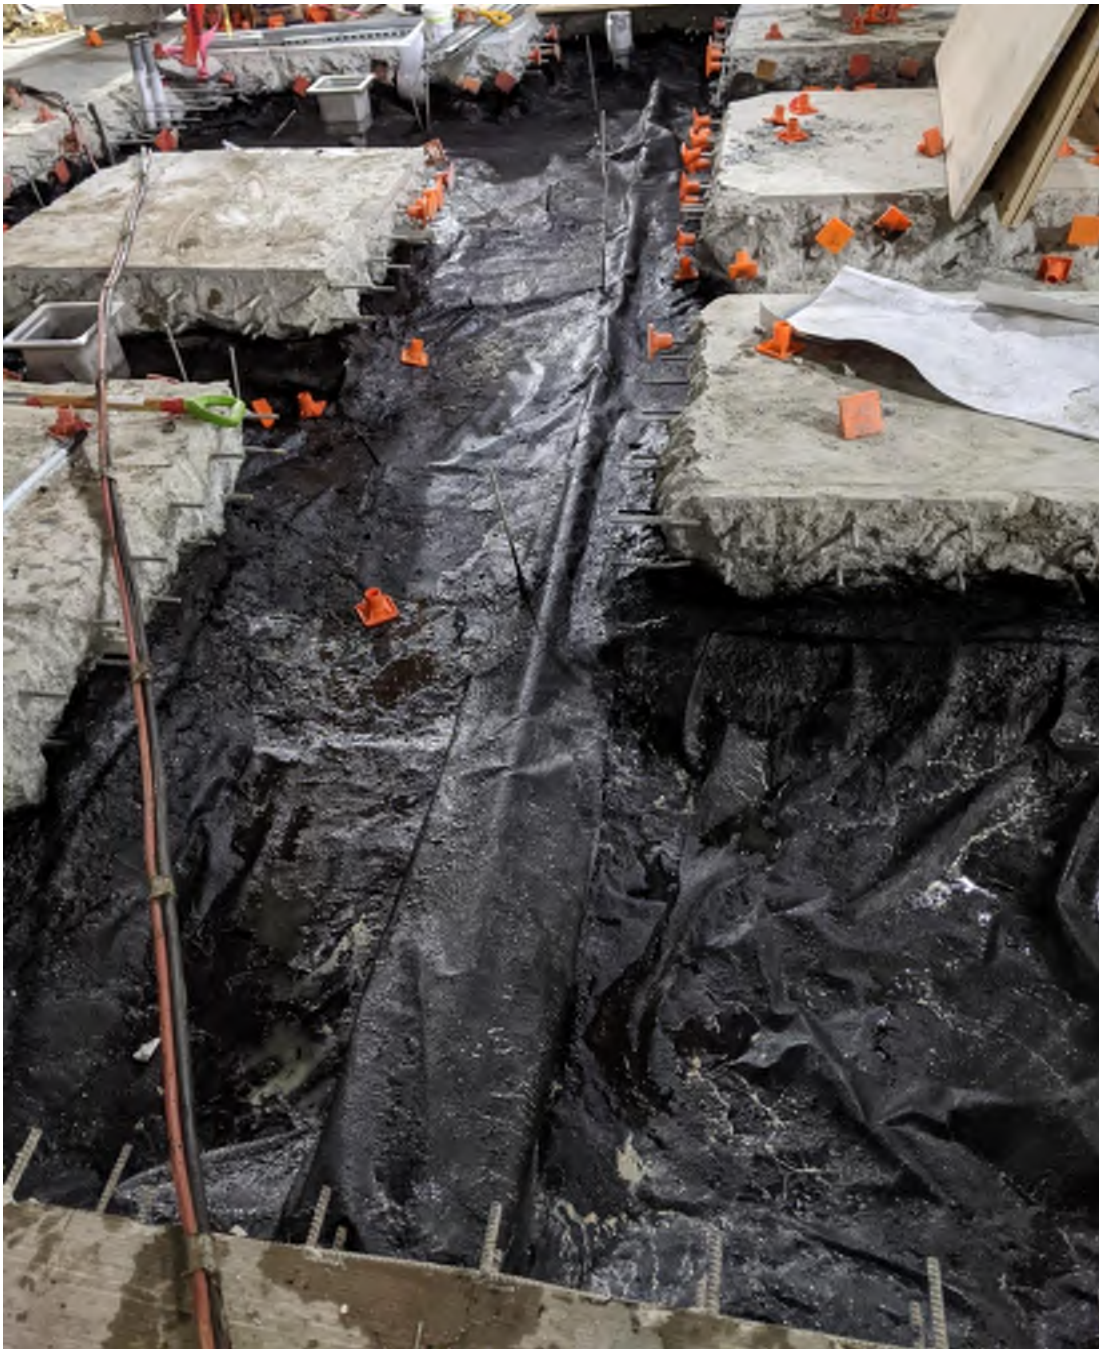
Photo 5: View of GMCS repair over 2" PVC gas extraction pipe (facing east).

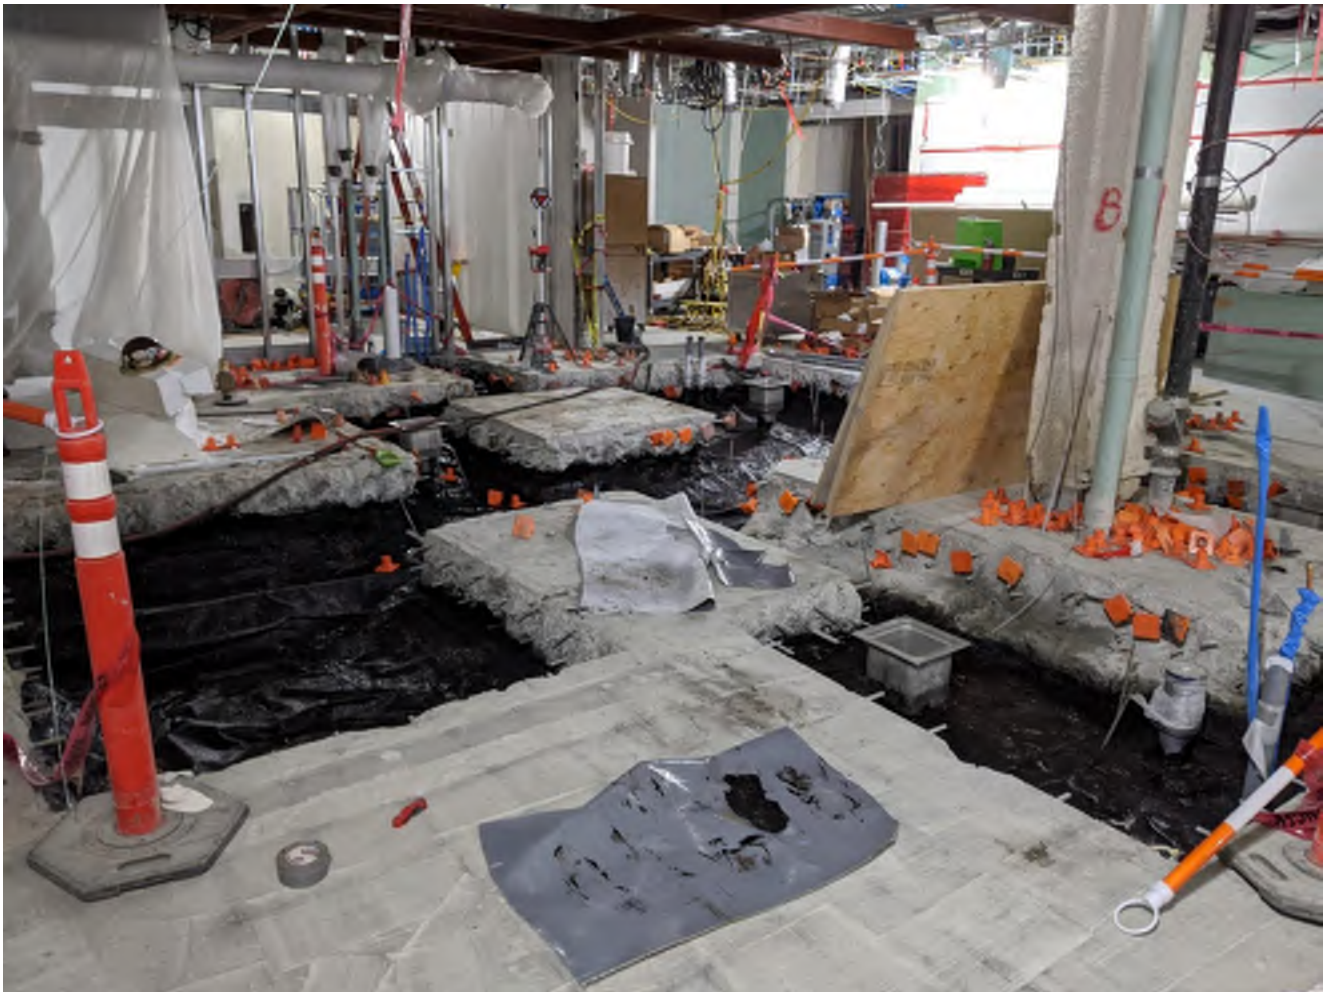
Photo 6: View of complete Phase 2 excavation GMCS repair (facing northwest).

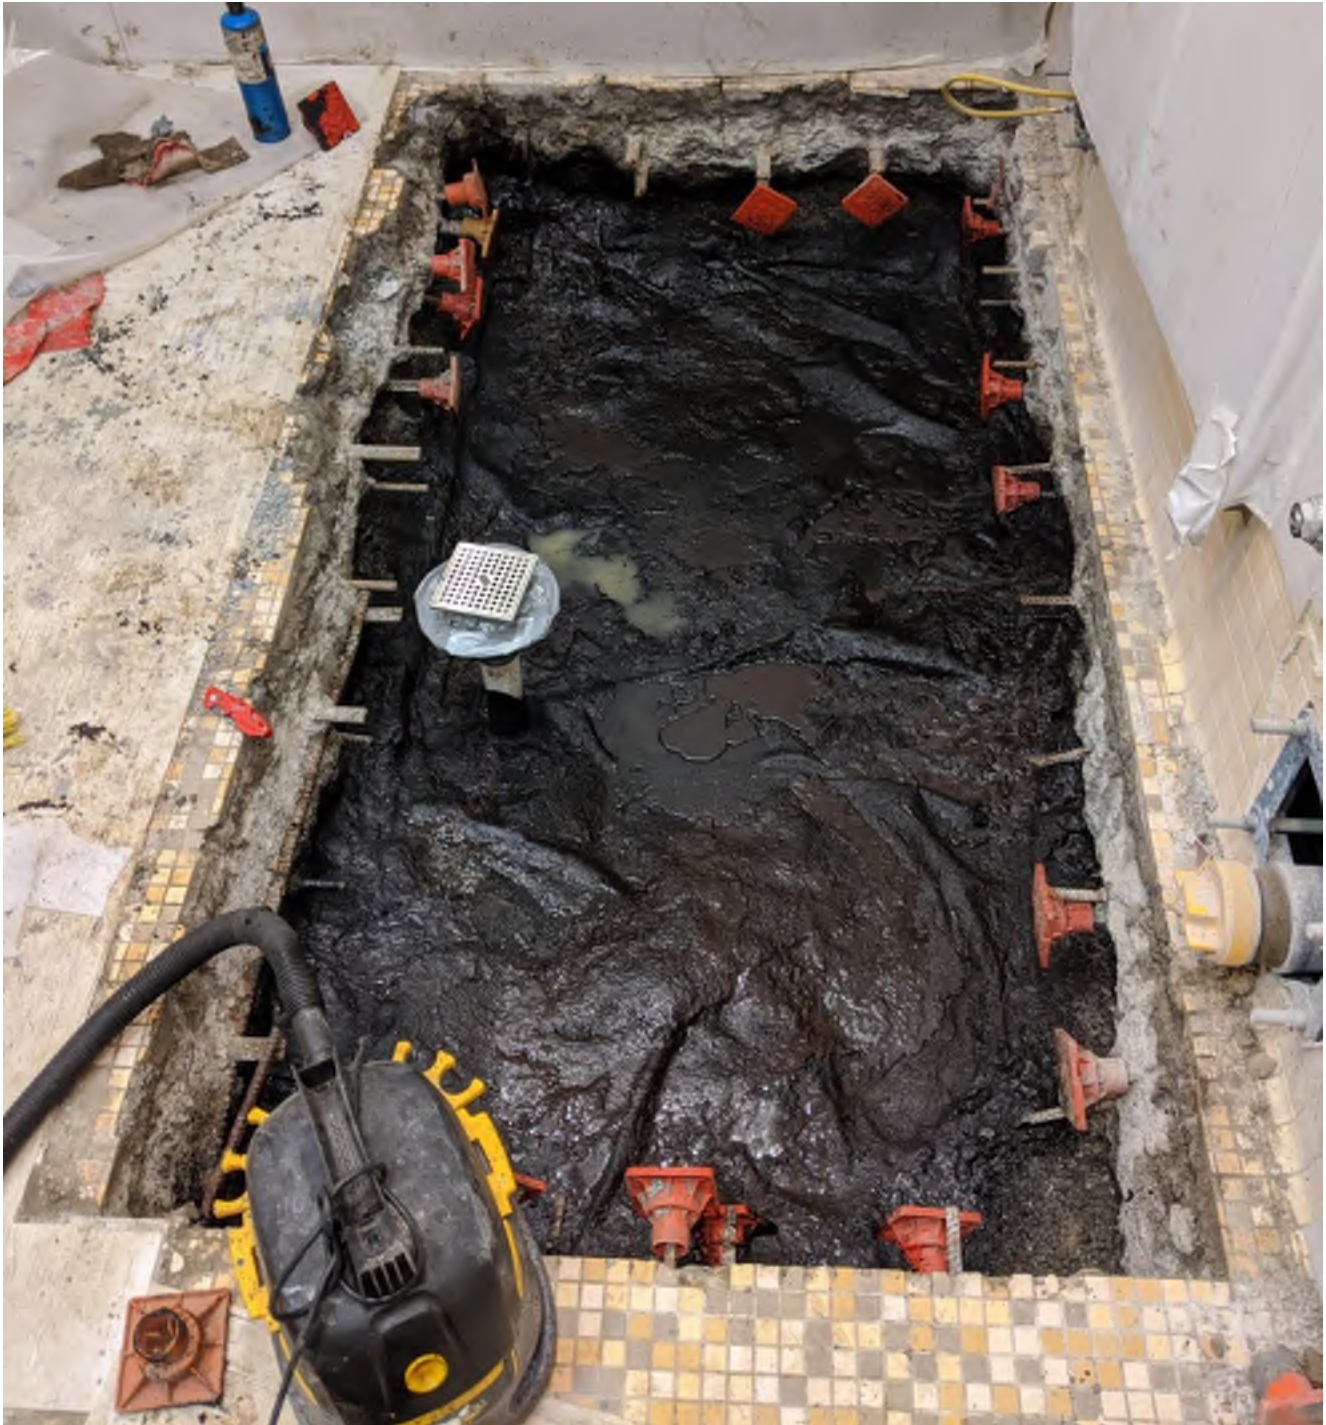
Photo 7: View of complete GMCS repair within men's bathroom (facing west)
